QUANTITATIVE ASSESSMENT OF FISH HABITAT CONDITIONS IN THE LOWER ELK RIVER

December 2, 2004

J.P. Ebell, I.D. Redden, A.Sc.T. & I.D. Cuthbert, R.P. Bio.
STREAMLINE ENVIRONMENTAL CONSULTING LTD.
786 Quilchena Cres.
Nanaimo, BC V9T 1P6
Phone: 250-758-7980
Fax: 250-758-8505

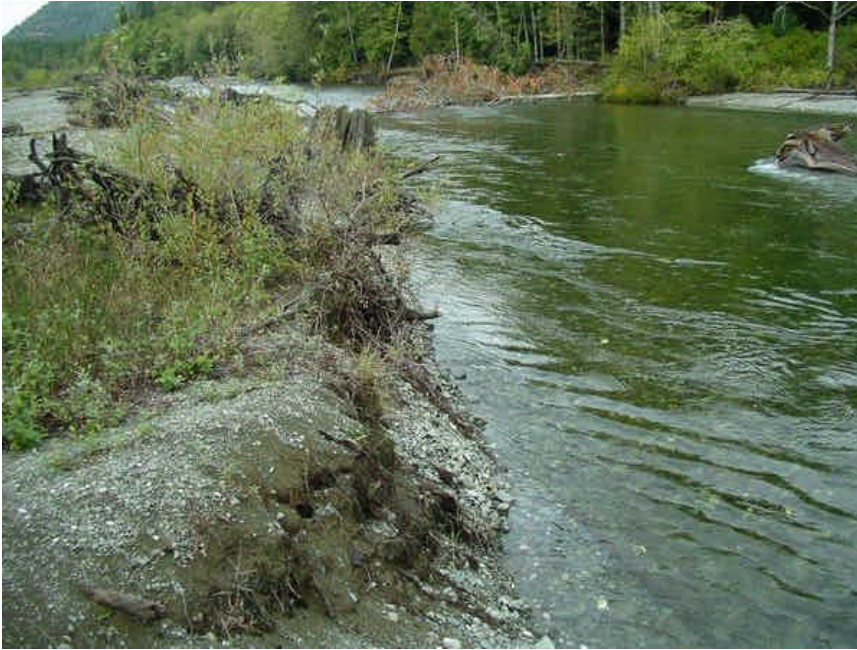
Photo 1. Reach 1, 0+050 m view upstream, typical. Sept 15, 2004

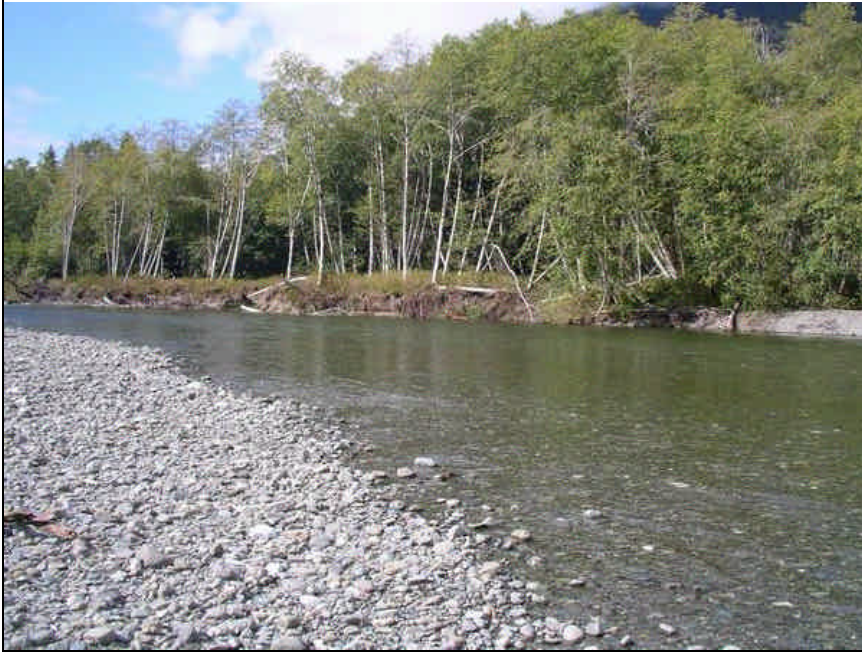
Photo 2. Reach 1, 0+225 m upstream view, typical. September 15, 2004

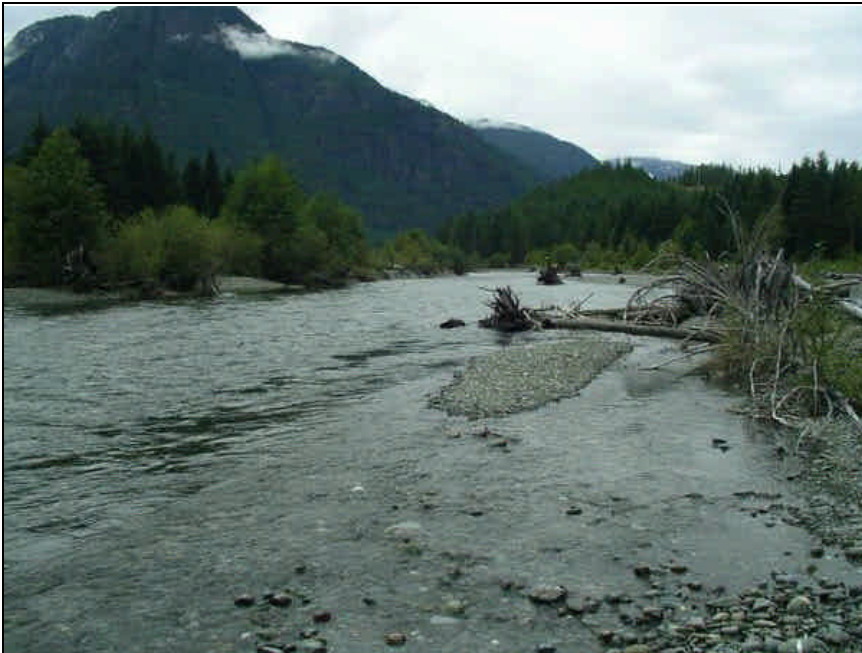
Photo 3. Reach 1, 2+886 m upstream view, typical. Sept 15, 2004

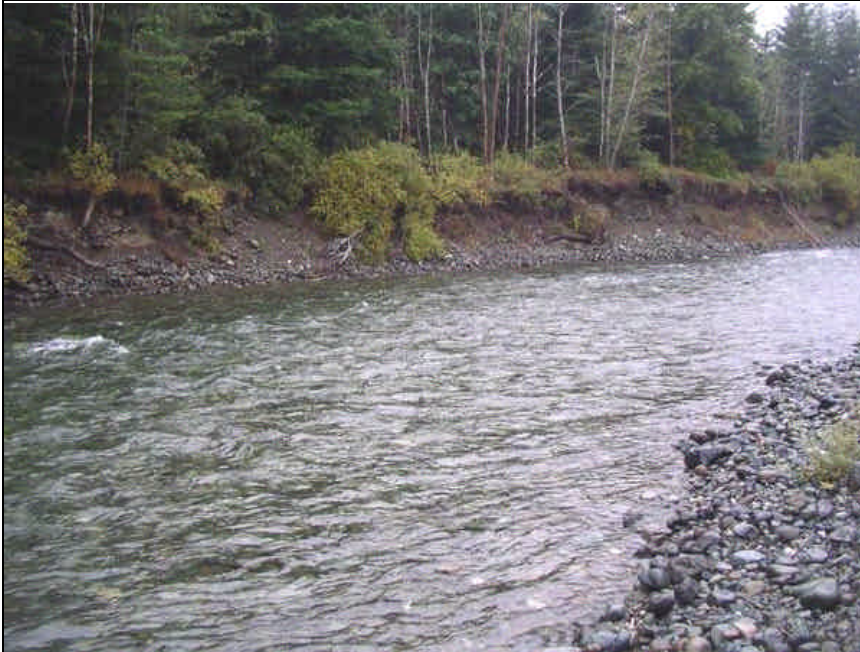
Photo 4. Reach 2, 6+403 upstream view, typical. September 16, 2004

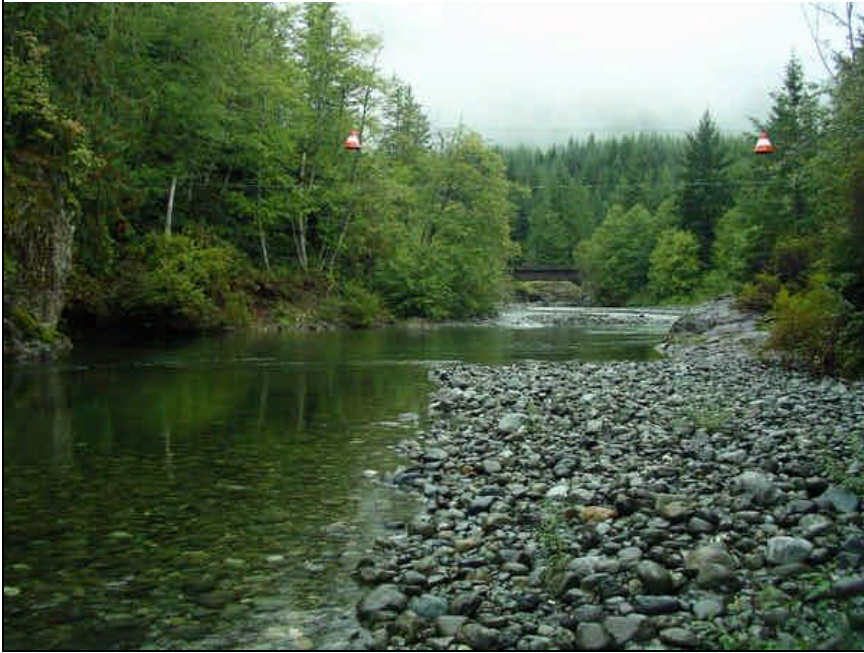
Photo 5. Downstream end of Reach 3, 6+763 m start of bedrock constriction. Note flow station cable and the ERT bridge in background. September 16, 2004.

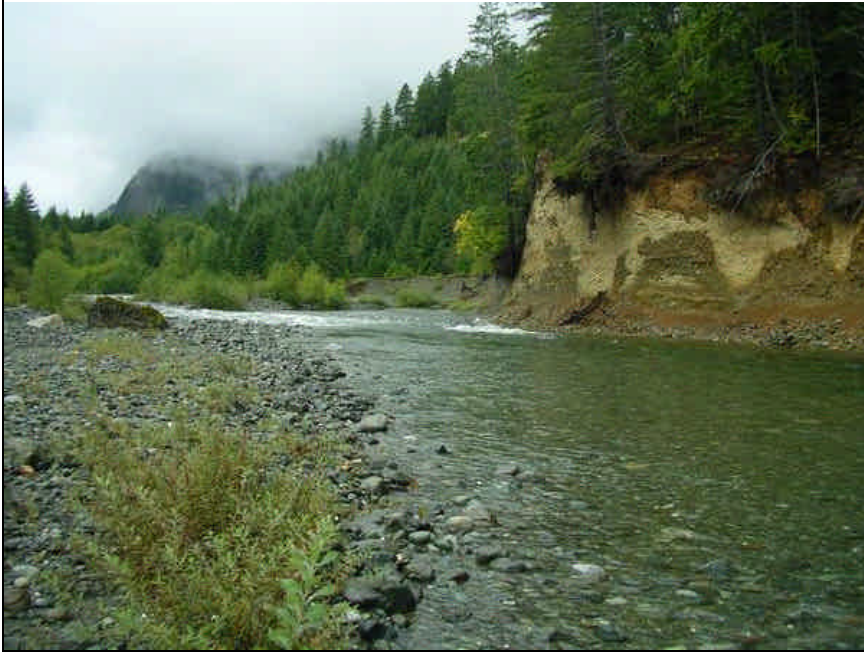
Photo 6. Reach 4, 7+792 m upstream view, typical. September 16, 2004

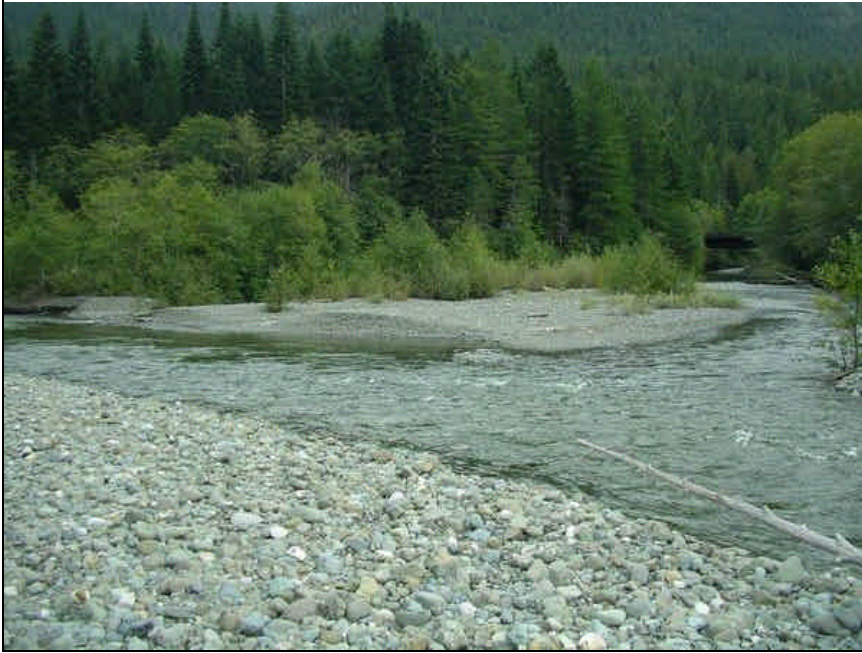
Well-defined pools were most often associated with unique topographic features such as a high bank, which forced a river direction change or a tributary inflow. Studies have shown that LWD normally plays a significant part in promoting pool frequencies. The assessment found that in some instances jams of LWD did create small pool sites however LWD in Elk River was generally observed to be small, scattered and often mobile. The scour areas associated with LWD were commonly insufficient in area and depth to meet the pool criteria of this study. Hydrological scour forces also appeared unable to maintain well-defined pools in normal pool sites such as outside bends and riffle bases. The lack of pool area is likely the result of dynamic substrate movement within the channel. Based on typical channel geometry and patterns, sites that normally would be expected to be pool areas were instead glide areas. This is reflected in the abundance of glides, which represent 51 % of available habitat in Reach 1, 28 % in Reach 2 and 30 % in Reach 4.

Photo 7. Reach 1 pool site at Cervus Creek inflow. September 15, 2004

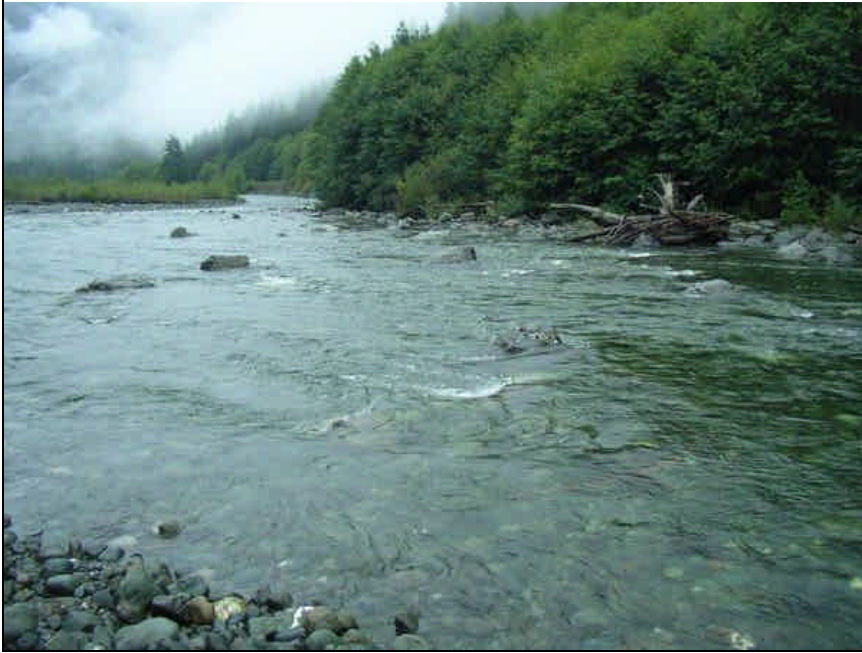
The effect of boulders within some glide and riffle units provided some surprising results in terms of potential cover and holding habitat. The alluvial substrate of the river offered few sites where large boulders existed however at a few locations boulders have accumulated from high banks. These boulders appeared partially moss covered and stable. The scour sites associated with these boulders rarely offered an area and depth that could be classified as a pool, however the quality of the habitat produced was of value for cover, holding and foraging. The presence and success of these boulder features in providing fish habitat complexity suggests that further investigation into the viability of addressing habitat needs using this template should be considered.

Photo 8. Reach 1, 6+342 m boulders functioning in mainstem, downstream view. September 16, 2004

The restoration of fish habitat by the promotion of pool forming structures may be of value however the risk of failure of instream wood and rock structures may be high at this stage in channel development. Channel stability has been assessed as being in a recovery and stabilizing mode (M. Miles 1999). A channel risk assessment is recommended to assess the opportunities for instream boulder and log structures.

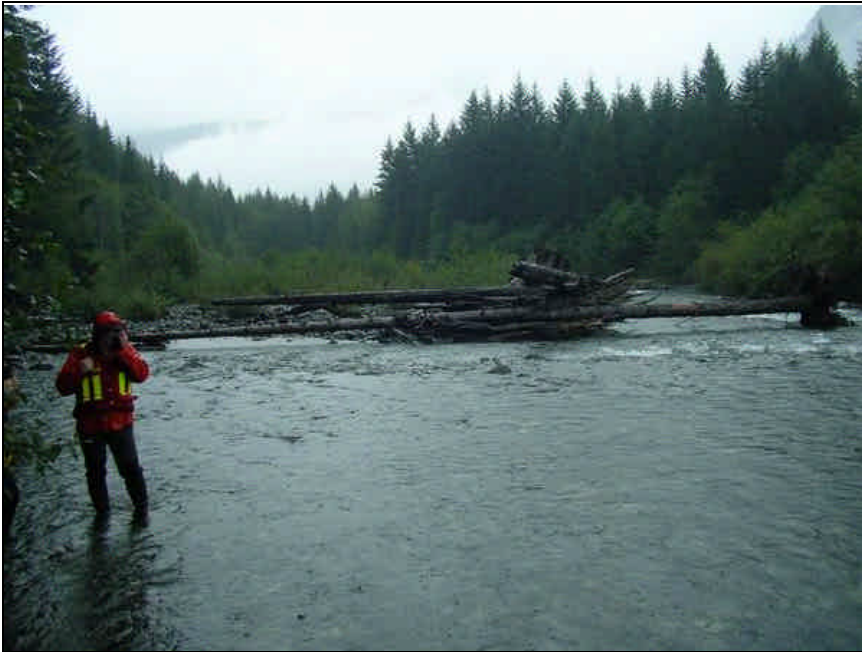
Within the wetted channel the functional pieces of LWD per channel width was assessed to be 1.7 in Reach 1 and 1.2 in Reach 2. Both these frequencies are diagnosed as “fair”. In Reach 4 the pieces of LWD per channel width decreased to 0.5 and was diagnosed as “poor”. The LWD was found to be relatively small compared to the channel. A majority of the wood is second growth logs that were small in diameter. Old growth and second growth stumps are also numerous offering only limited cover or scour value as individual structures. Alder logs that have a relatively short functional LWD lifespan were also noted to be a significant component of the LWD tallied. The wood was generally noted to be not well anchored and subject to move from event to event.

Photo 9. Reach 4, 7+260 m woody debris functioning to stabilize bar, downstream view. September 16, 2004

Channel instability is recognized as a significant concern in the Elk River. During 2004, BCRP initiated a gravel bar staking project to begin addressing this concern. On the gravel bars, numerous examples were seen of LWD functioning to promote bar stabilization and re-vegetation. In many sites throughout the alluvial reaches there appears to be the opportunity to assist bar stabilization and the formation of a single

thread channel through the addition of further LWD on more active bar sites. A channel-risk assessment is recommended to confirm the opportunities for this work.

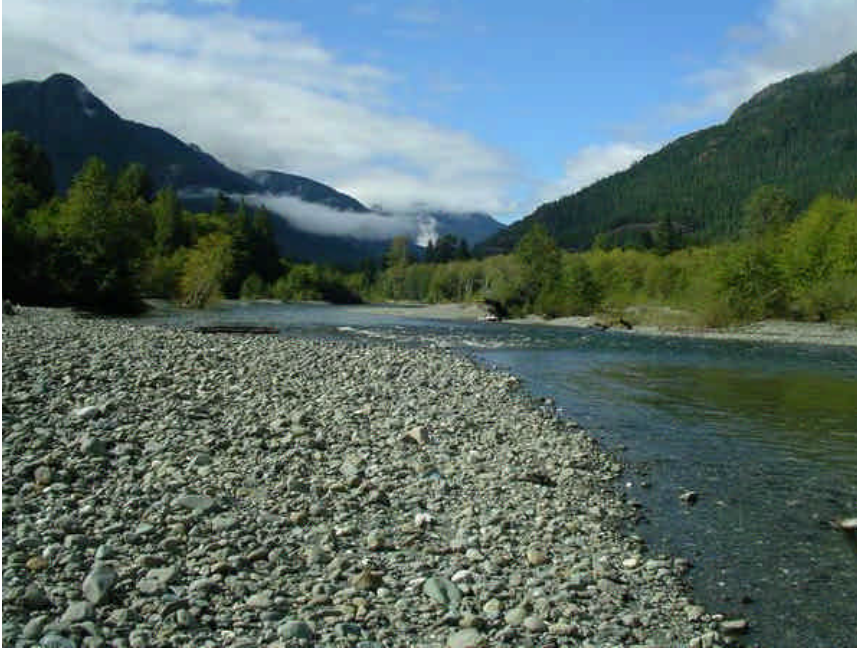
A mature riparian forest of conifers or mixed species is essential to both bank stability and a quality supply of LWD. Within the Elk River healthy mature forests accounted for 24 % of the total riparian vegetation in Reach 1, 47 % in Reach 2, 76 % in Reach 3 and 37 % in Reach 4. Thus a majority of the channel length is vegetated in various stages of young and deciduous forests providing limited riparian values. This is particularly the case in Reaches 1 and 4, which account for the majority of the channel length surveyed.

Photo 10. Reach 1, 1+166 m upstream view of typical reach with young deciduous forest. September 15, 2004

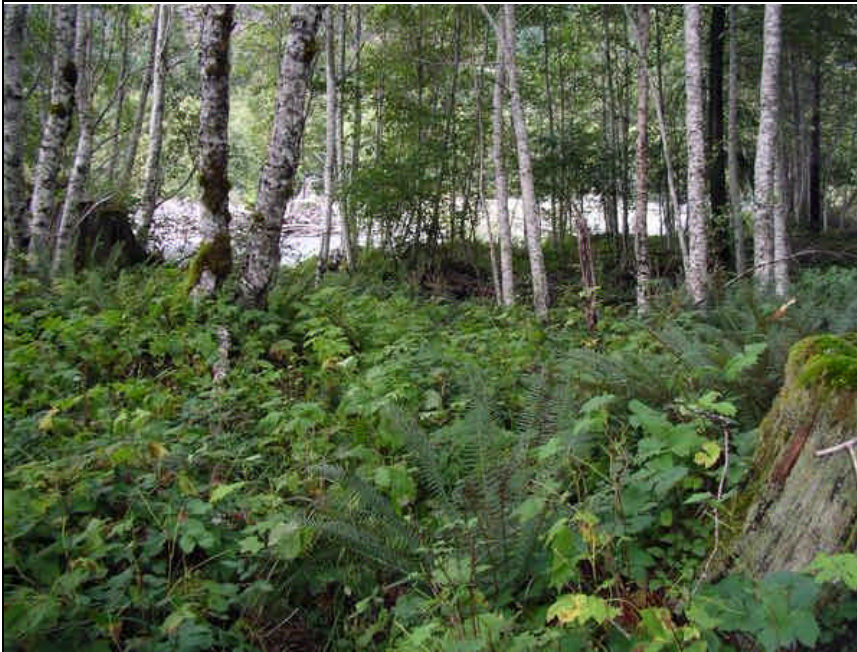
Photo 11. Deciduous riparian area in Reach 1 with no conifer under story. Note old growth cedar stumps. September 15, 2004

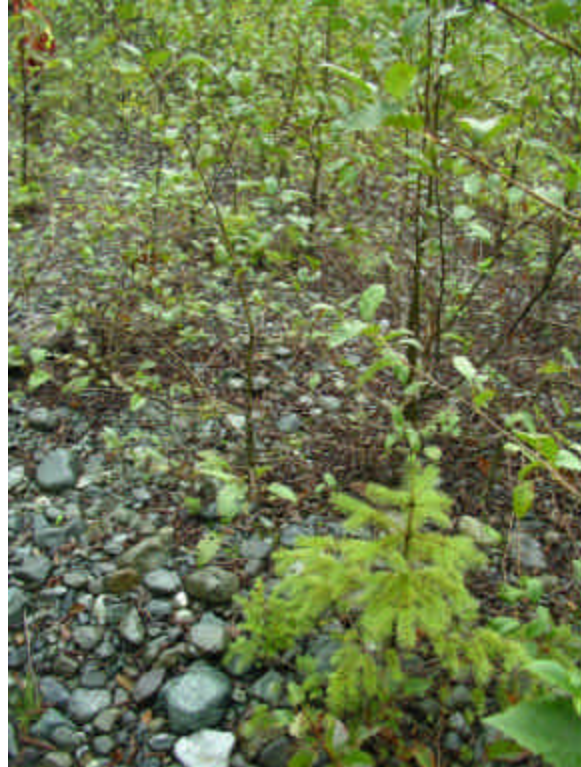
The riparian assessment completed in this study offers only a cursory understanding of the current habitat conditions and needs. Reconnaissance walks through the riparian types noted varying conditions in each broad category. Within some deciduous forests, young conifers are established as an understory species while in other deciduous sites conifers were devoid and the understory diversity was marginal. On some sites tree growth was rapid while on others sites it was not. This was particularly the case for young seedling conifers that appeared chlorotic and stunted at some sites while showing good growth in others.

Photo 12. Chlorotic conifer seedling commonly observed to be in need of nutrient and alder release. September 16, 2004

A thorough riparian assessment is recommended along with prescription development.

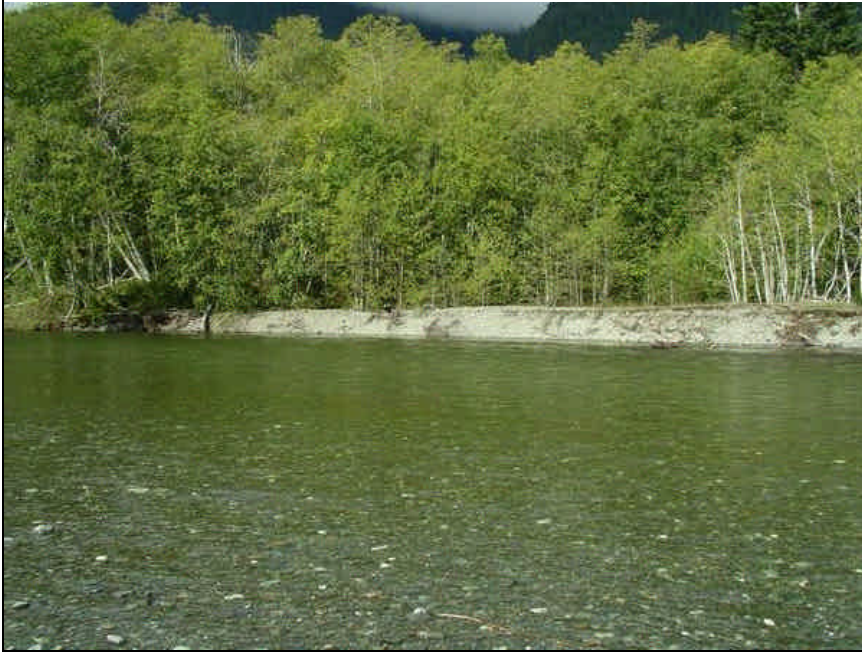
Actively eroding banks were present along 30 % of reach 1, 39 % of Reach 2, 6 % of reach 3 and 40 % of reach 4. This erosion activity was taking place on both low-lying gravel banks as well as high hardpan banks. Substrate eroding from these banks sites is being carried by the river as bed load and redistributed within the system. This is undoubtedly contributing to river instabilities and a loss of habitat. As discussed above, the weak riparian structure plays an important role in this situation.

Photo 13. Reach 1, 0+137 m bank erosion and weak riparian structure. September 15, 2004

Opportunities to address bank stability lie in improvements to and maturity of the riparian area. Stabilizing peak flows and reducing diversions from other watershed will also play an important role in allowing banks to stabilize. At some sites specialized bioengineering or in channel energy dissipation may offer relief and an opportunity for bank stabilization.
