RE: CONUMA RIVER SIDE CHANNEL PROPOSED DEVELOPMENT FEASIBILITY STUDY December 2002 Site Inspection

CONUMA RIVER INSPECTION REPORT December 2002 Site Visit Page 2 of 11

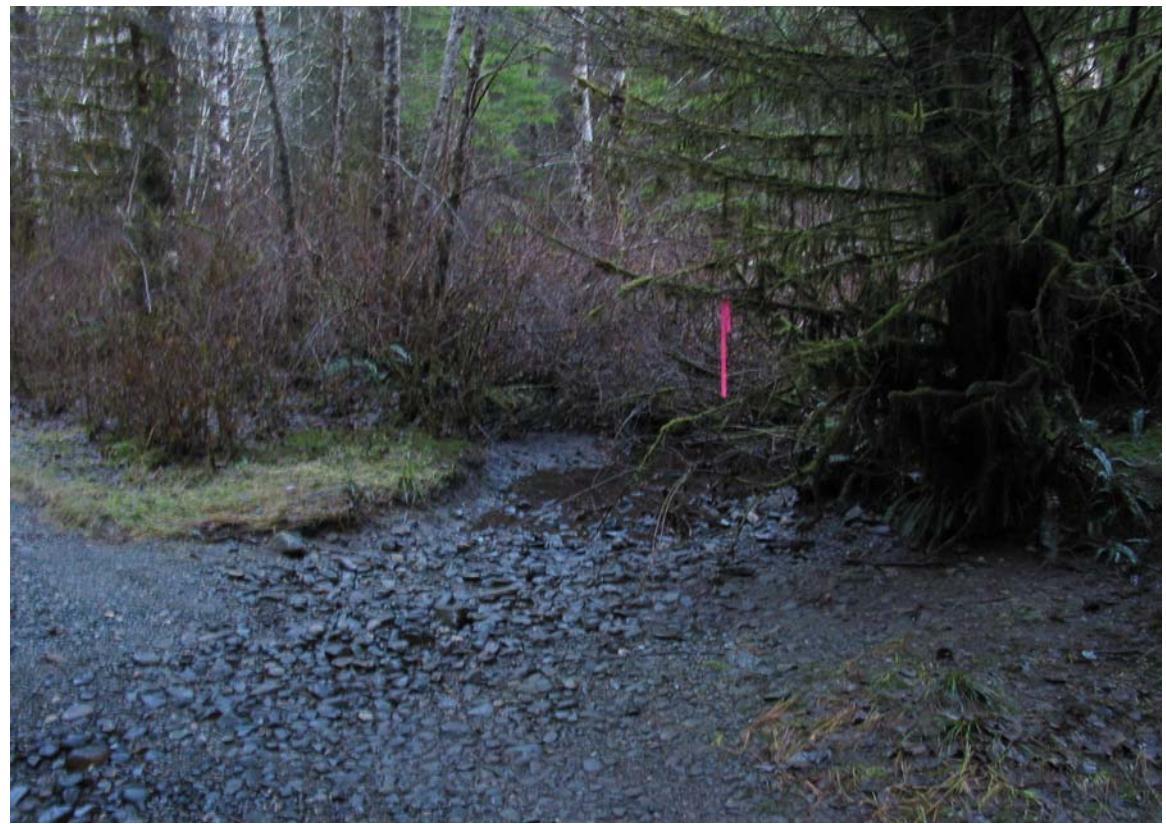
The floodplain is dissected by several continuous but only partially wetted swales. The lower 400m of the swales contain isolated pools, short flowing sections, and small pockets of gravel (Photos 3 to 8). The lower 300m of the swales are thought to be tidal and contain brackish water at twelve-foot tides. Above 400m, the main swale branches into two forks: one that leads to the small-unnamed tributary at the mainline and one that continues closer to the centre of the site (Figure 2). The tributary branch runs along the toe of the unnamed tributary's alluvial fan. It contains evidence of occasional larger flows that have scoured the bed, producing a small sediment lobe about 600m upstream of Conuma River. The branch ends in a small pond located beside the forestry road, adjacent to the alluvial fan. The centre swale runs almost continuously from the fork to within 200m of the hatchery. The upper 700m of this depression has occasional isolated ponds, swampy sections and overgrown sections. The swales end about 200m of the hatchery where the ground rises. A test pit excavated in this section of the floodplain in August 2002 failed to detect groundwater within 3m of the ground surface.

Photo 3: The lower swales where they cross the main access road.

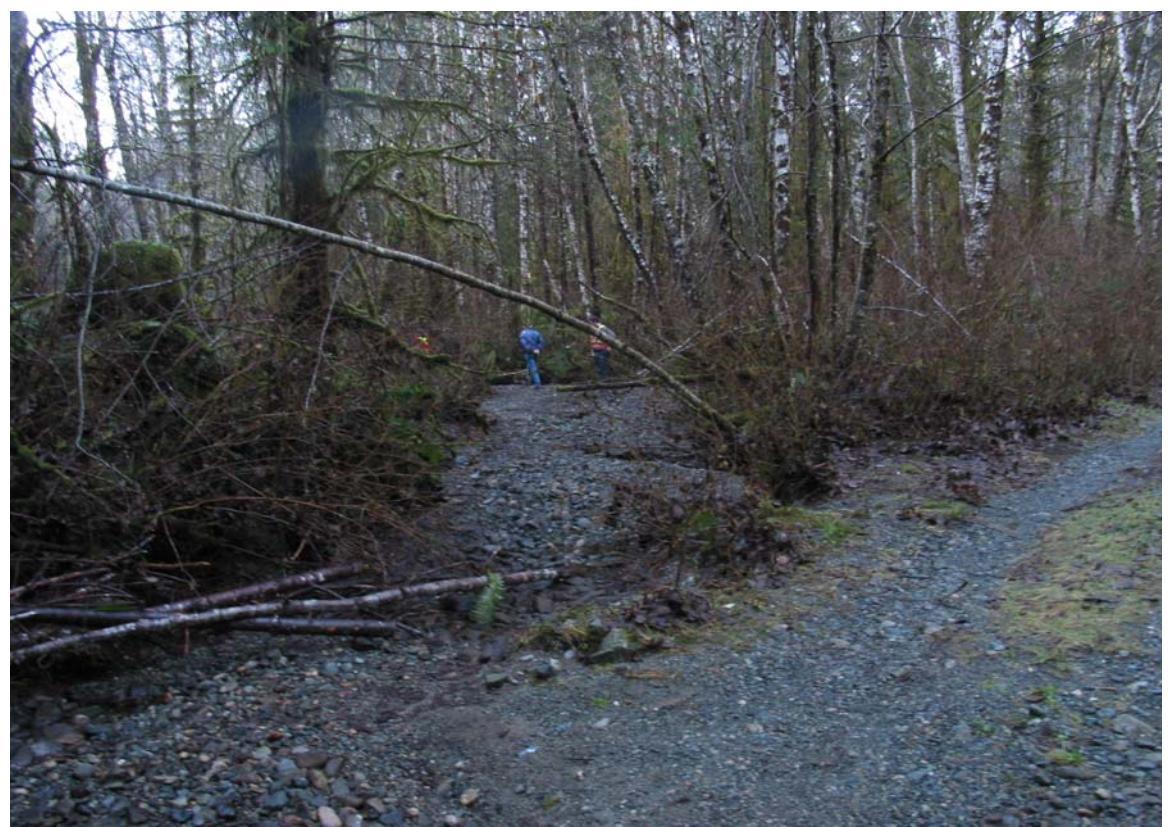
tel (604) 980-6011 fax (604) 980-9264 nhc@nhc-van.com www.nhcweb.com Conuma River shows signs of recent aggradation and significant overbank flooding. A large November 2002 storm inundated large portions of the right floodplain under 1m to 1.5m depth. This water entered the lower section of the proposed site. Any channel excavated in this area will require a berm to prevent the overbank floods that travel along the roads from entering the channel. Alternatively, a channel could be designed to allow these floods to pass through the channel without significant damage. However, this option would include some risk of sediment carried with the flood flows filling the channel.

Photo 4: Looking upstream into the main swale at about 300m upstream of Conuma River. Note the sediment lobe due to overbank flow from Conuma River.

- 6). We recommend that overbank flow from Conuma River be prevented from entering the channel by the construction of a continuous berm located between the river and the channel. The berm would likely terminate where the existing channel crosses the main access road.

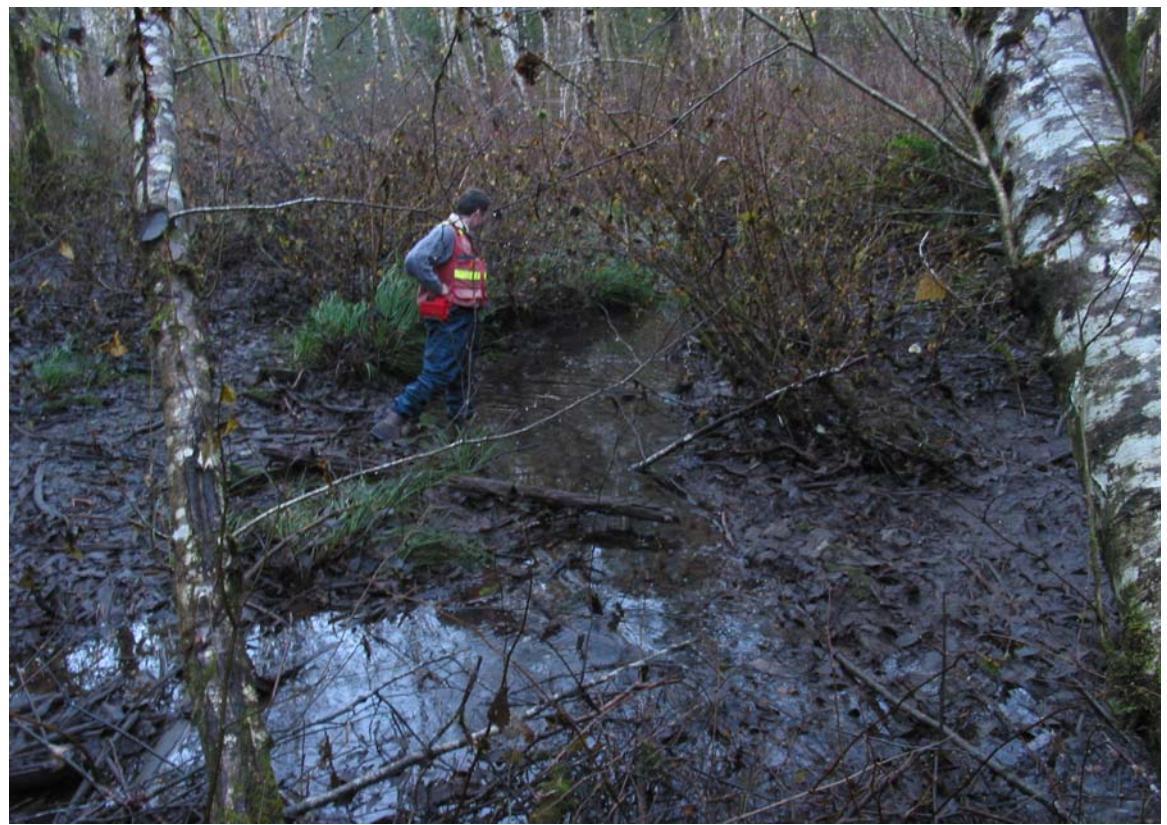
Photo 5: Isolated pools and short flowing sections of the lower swales.

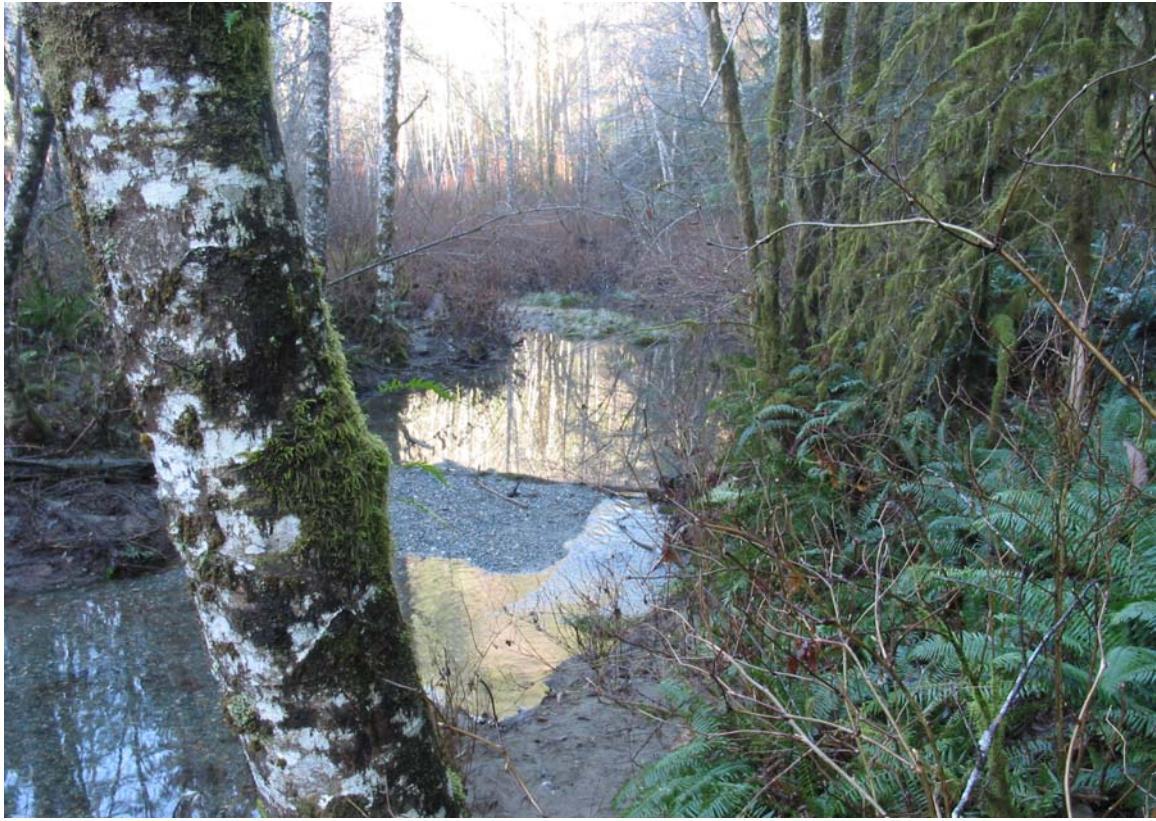
Photo 6: Larger gravel section in the lower swales.

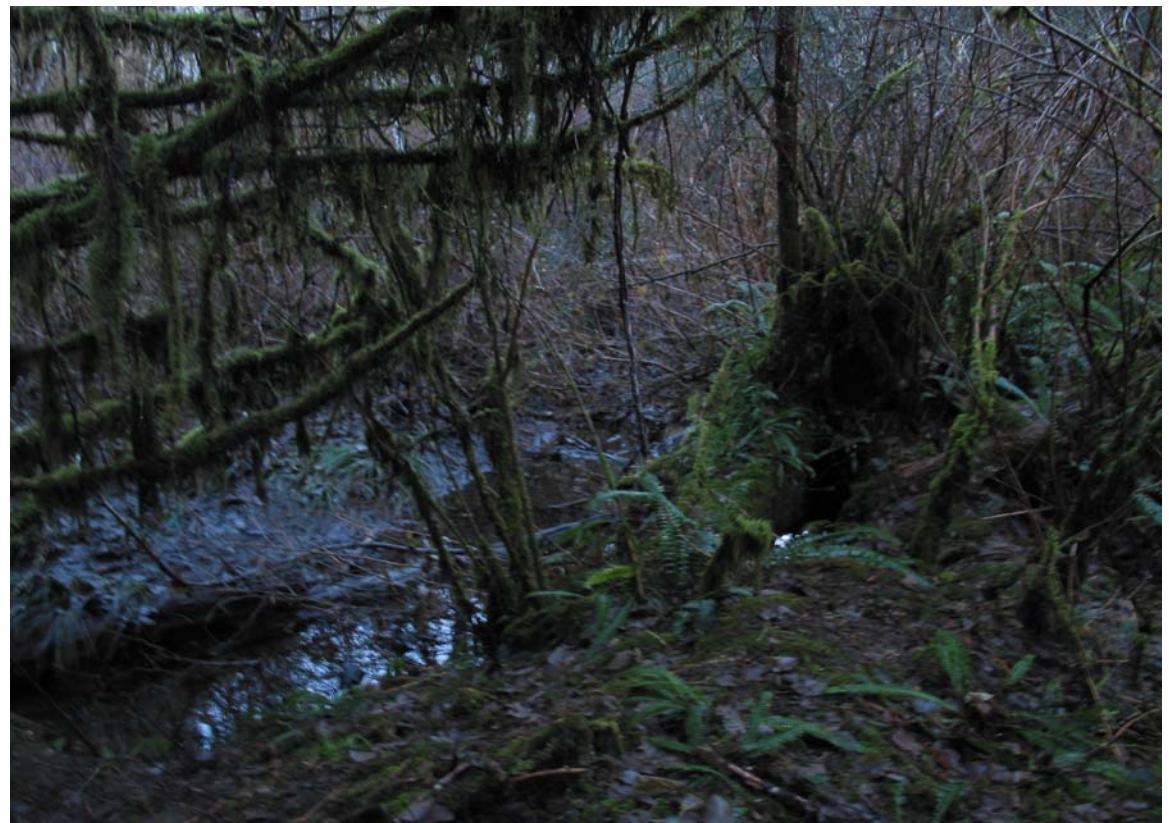
Photo 7: Overgrown and ponded sections of the swales.

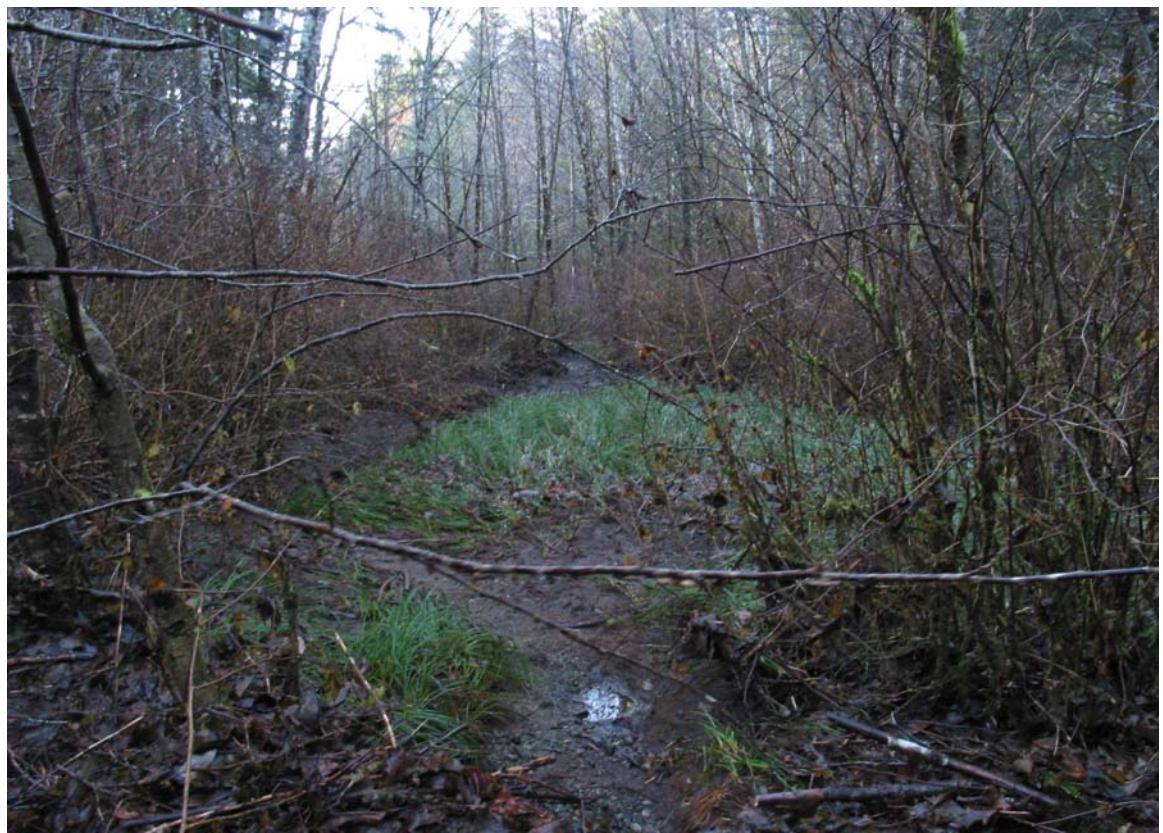
Photo 8: The upstream extent of flowing water at about 500m on December 5.

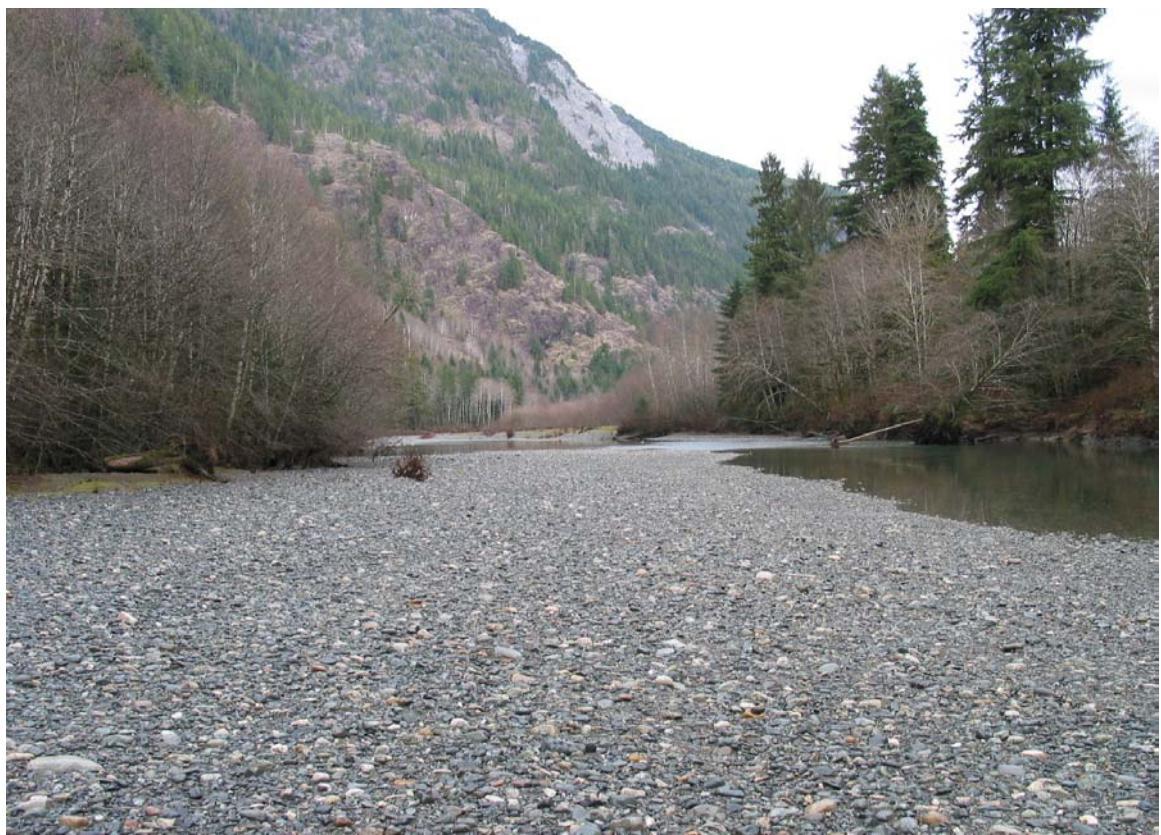
Our first impression of Conuma River (this needs to be confirmed by historic aerial photo investigation) is that the reach near the hatchery is aggrading. This reach, which lies immediately upstream of the delta, would be the depositional area for gravels and cobbles transported from the upper watershed. The river appears wide and has abundant sediment that fills the channel (Photo 9). An inspection of the main river near the proposed site revealed very large bars that crest at or above the top of the stream bank (Photo 10). As a result, there has been significant flow over the bank in the recent past, leading to the erosion of several small side channels through the bank. In the long-term, lateral instability of Conuma River above the delta and near the proposed channel could affect the project.

Photo 9: Looking upstream at Conuma River just below the hatchery. The proposed channel site lies behind the alders to the left of the photo.

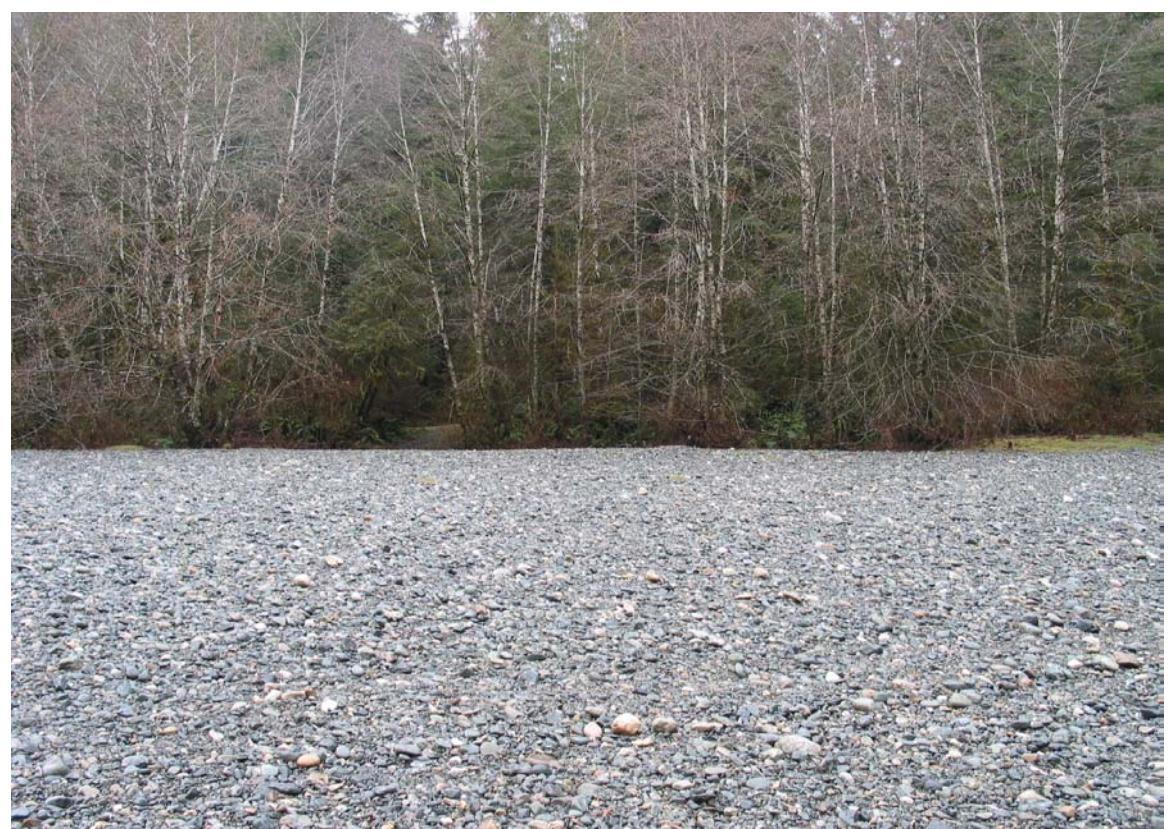
Photo 10: Looking toward the right bank of Conuma River adjacent to the proposed site. Note the height of the gravel bar and the small channels leading into the trees.

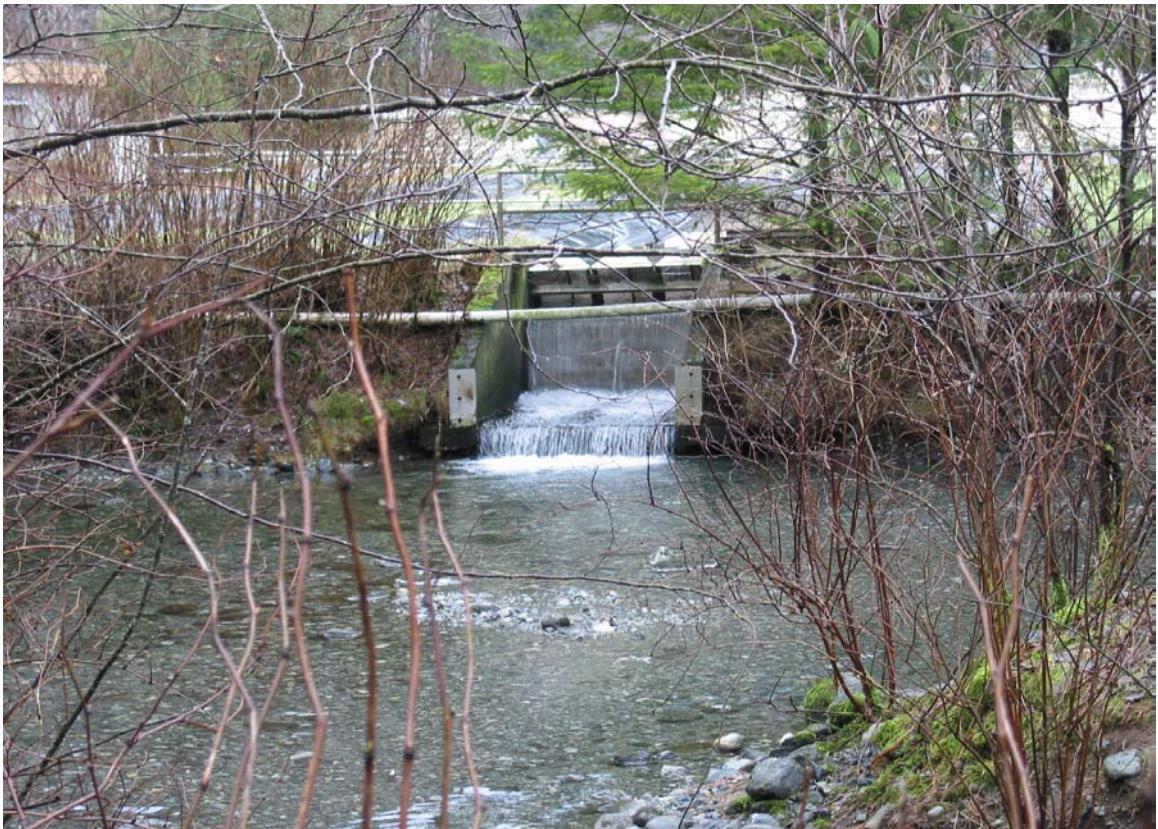
Photo 11: The hatchery outfall.

- 9). All of the water spilled from the hatchery could be diverted into the rearing channel. Fish should be prevented from entering the current overflow channel because we suspect that it will dry during base flow conditions without the hatchery input.

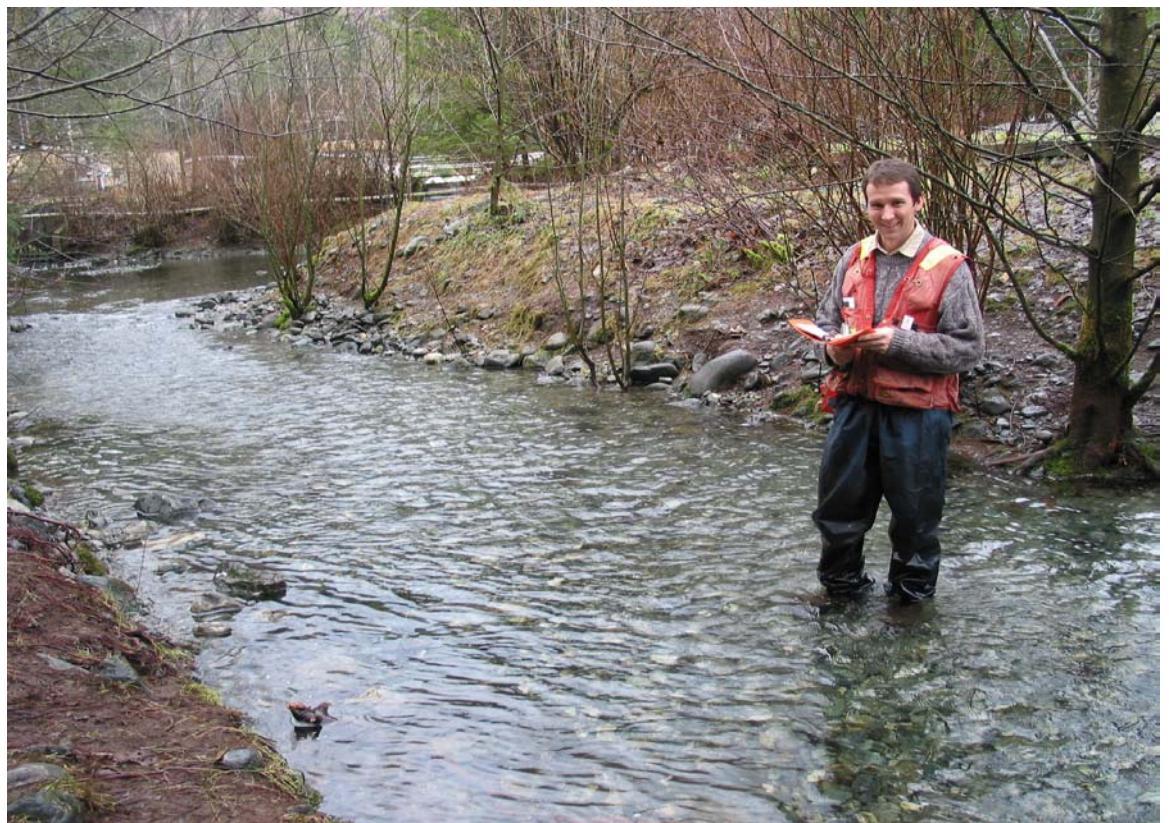
The current outlet channel of the hatchery provides a good template for the rearing channel construction (Photos 11 and 12). This stable channel has a width of 4 to 5m, lies on a gentle slope of less than 1% between drop structures, and has bed material composed of sands and gravels. The banks are stable, are vegetated by grasses and small shrubs, and are angled at about 2 horizontal to1 vertical (2H:1V). During the inspection, the discharge from the hatchery was about 500L/s, providing a water depth of 0.6 to 0.7m and a mean velocity of 0.2m/s. The frequent redds and adult spawners in the channel suggest that these conditions are suitable for spawning.

Photo 12: The stable hatchery outlet channel.

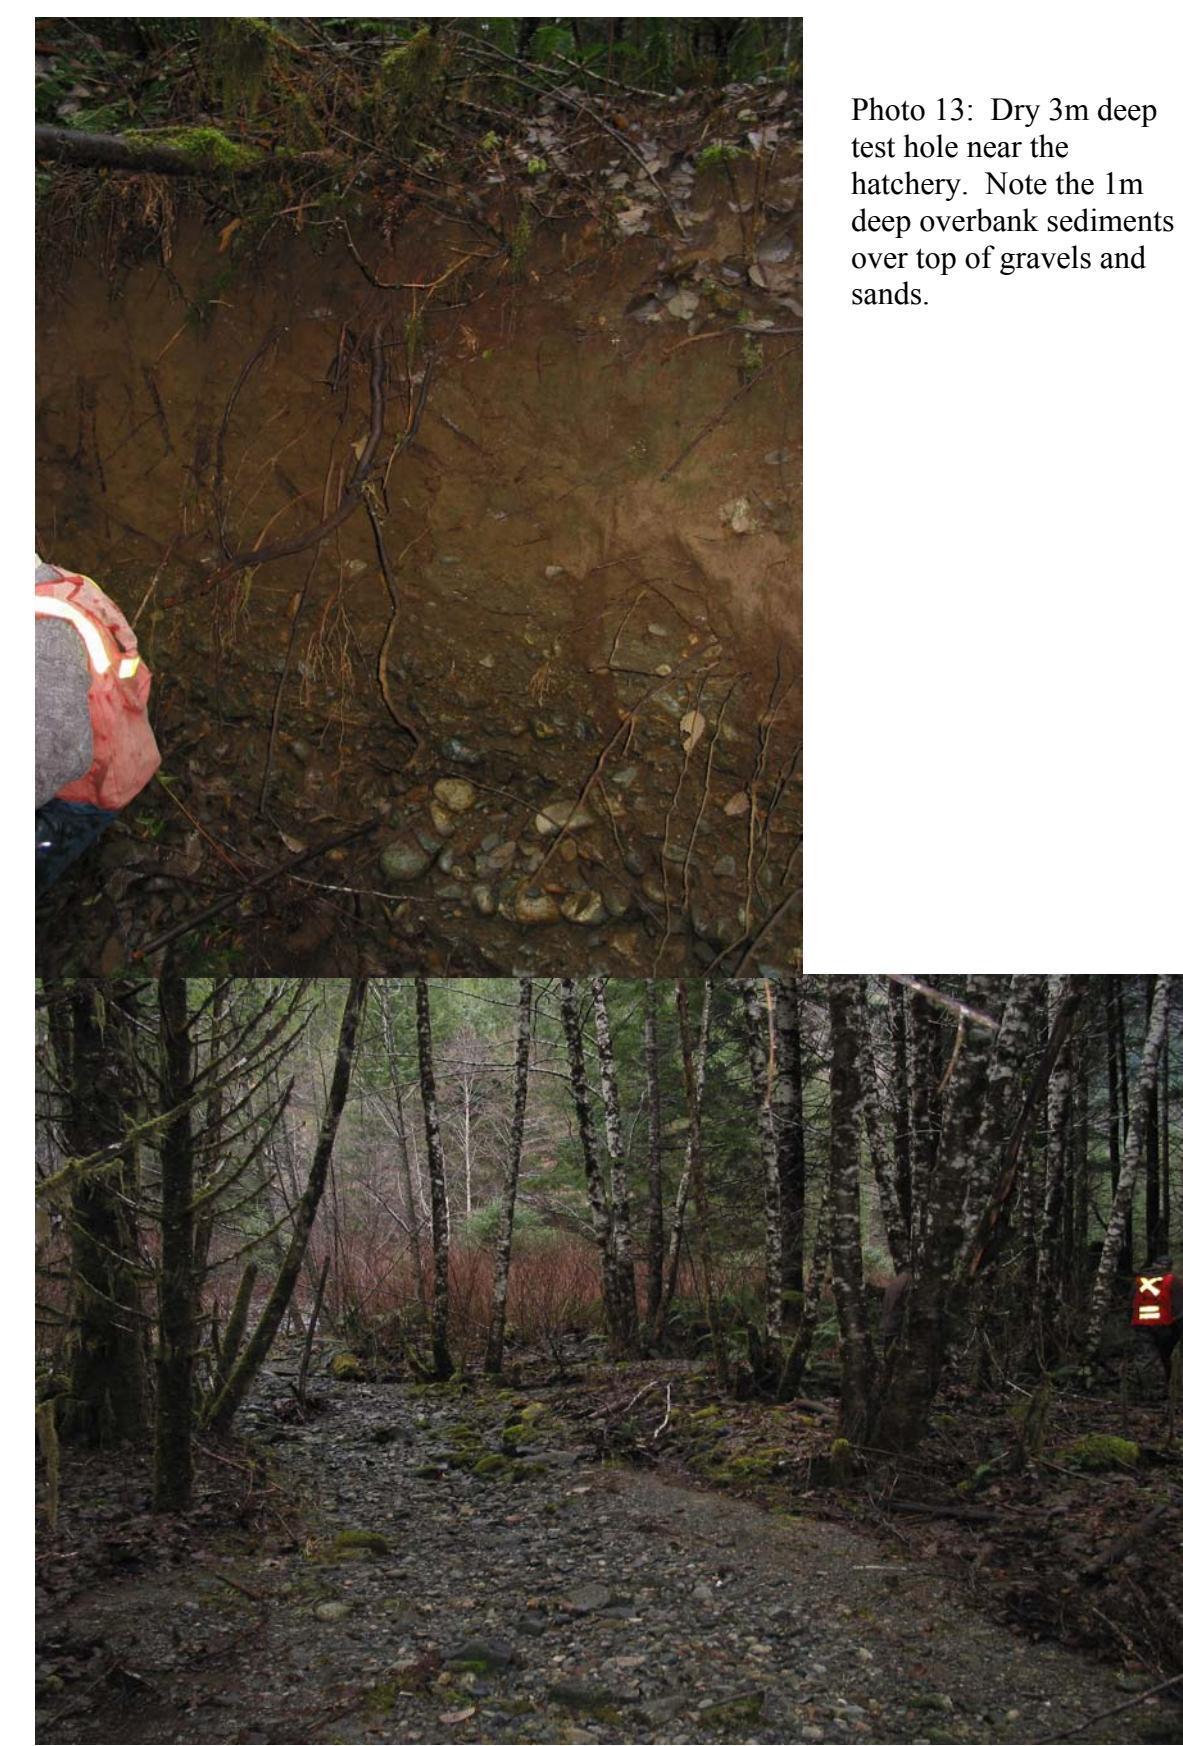
The unnamed, right bank tributary is also a potential source of both water and sediment to the channel. Below the mainline culvert, the stream channel is entrenched into the fan surface and laterally stable. However, as the stream enters the BC Hydro right-of-way a sediment lobe fills the channel. This sediment lobe causes the stream to split into several channels, each transporting some gravels and sands down to the swales. This lateral instability and multiple location of sediment delivery should be accommodated in the design of the rearing channel.

Photo 14: Gravel transport down the laterally unstable channels on the unnamed tributary alluvial fan. This source of sediment will have to be incorporated into the channel design.

- 4). We recommend that the small alluvial fan and unstable channel of the unnamed tributary be incorporated into the long-term design of the channel. The design should incorporate both the water and sediment delivered by this stream and address or account for the channel stability on the fan.

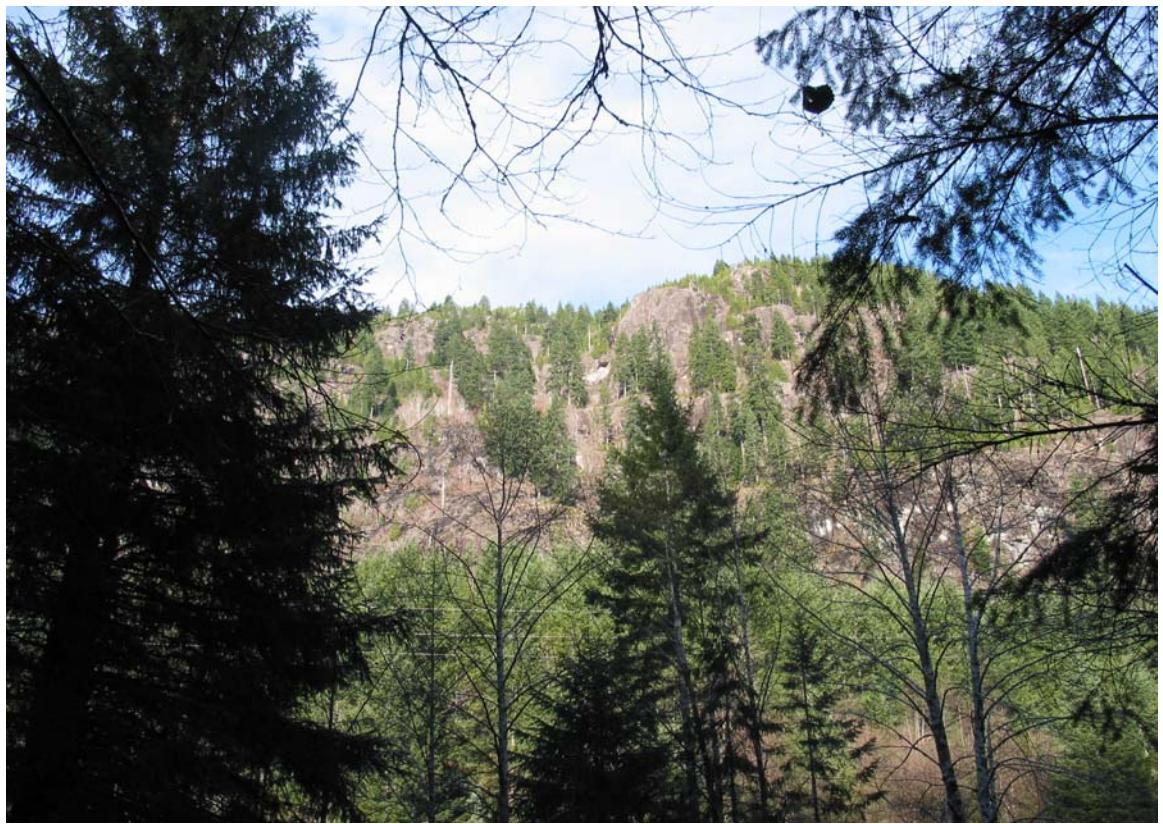
Photo 15: Looking up at the bedrock dominated watershed of the unnamed tributary.

- While no debris flow evidence was found below the unnamed tributary and 5). bedrock can be seen to dominate the tributary's watershed, we recommend that the upper watershed be examined by historic aerial photograph and by foot for the possibilities of landslides and debris flows.
