RE: CONUMA RIVER SIDE CHANNEL PROPOSED DEVELOPMENT FEASIBILITY STUDY December 2002 Site Inspection

CONUMA RIVER INSPECTION REPORT December 2002 Site Visit Page 2 of 11

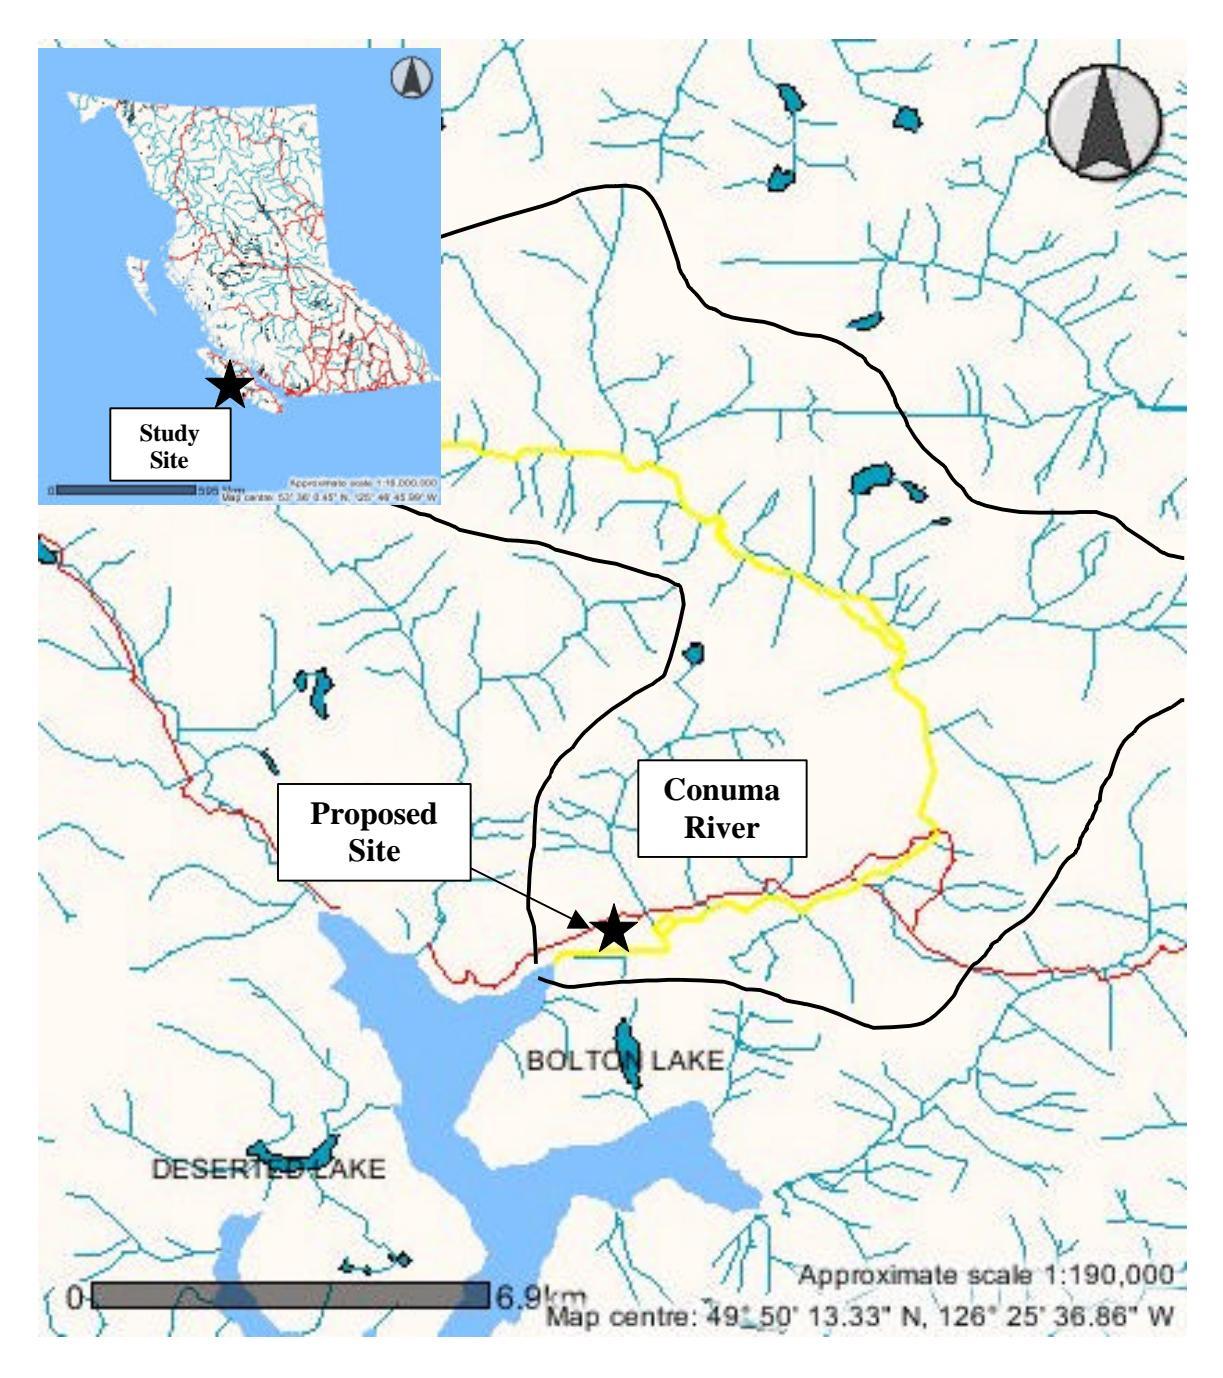
Figure 1: Study Site

The Conuma River is one of the largest rivers draining into Nootka Sound on Vancouver Island's West coast (Figure 1). As such, it is an important producer of anadromous salmonids returning to the sound. To augment the natural production of chum salmon in the river, DFO constructed a fish hatchery on the right floodplain in 1978 (DFO, 2002). While the main purpose of the hatchery was to augment the natural chum population of the river to support a commercial fishery, the hatchery also raised coho, chinook and steelhead salmon to offset any incidental catch in the commercial fishery (DFO, 2002). The success of the hatchery at raising chinook salmon, in particular, has increased the return of this species from a historical level of 1,000 to 3,000 spawning adults to 13,000 to 25,000 spawning adults. This has led to an increase in sport fishing in the area, an important revenue source for the nearby towns of Gold River and Tahsis.

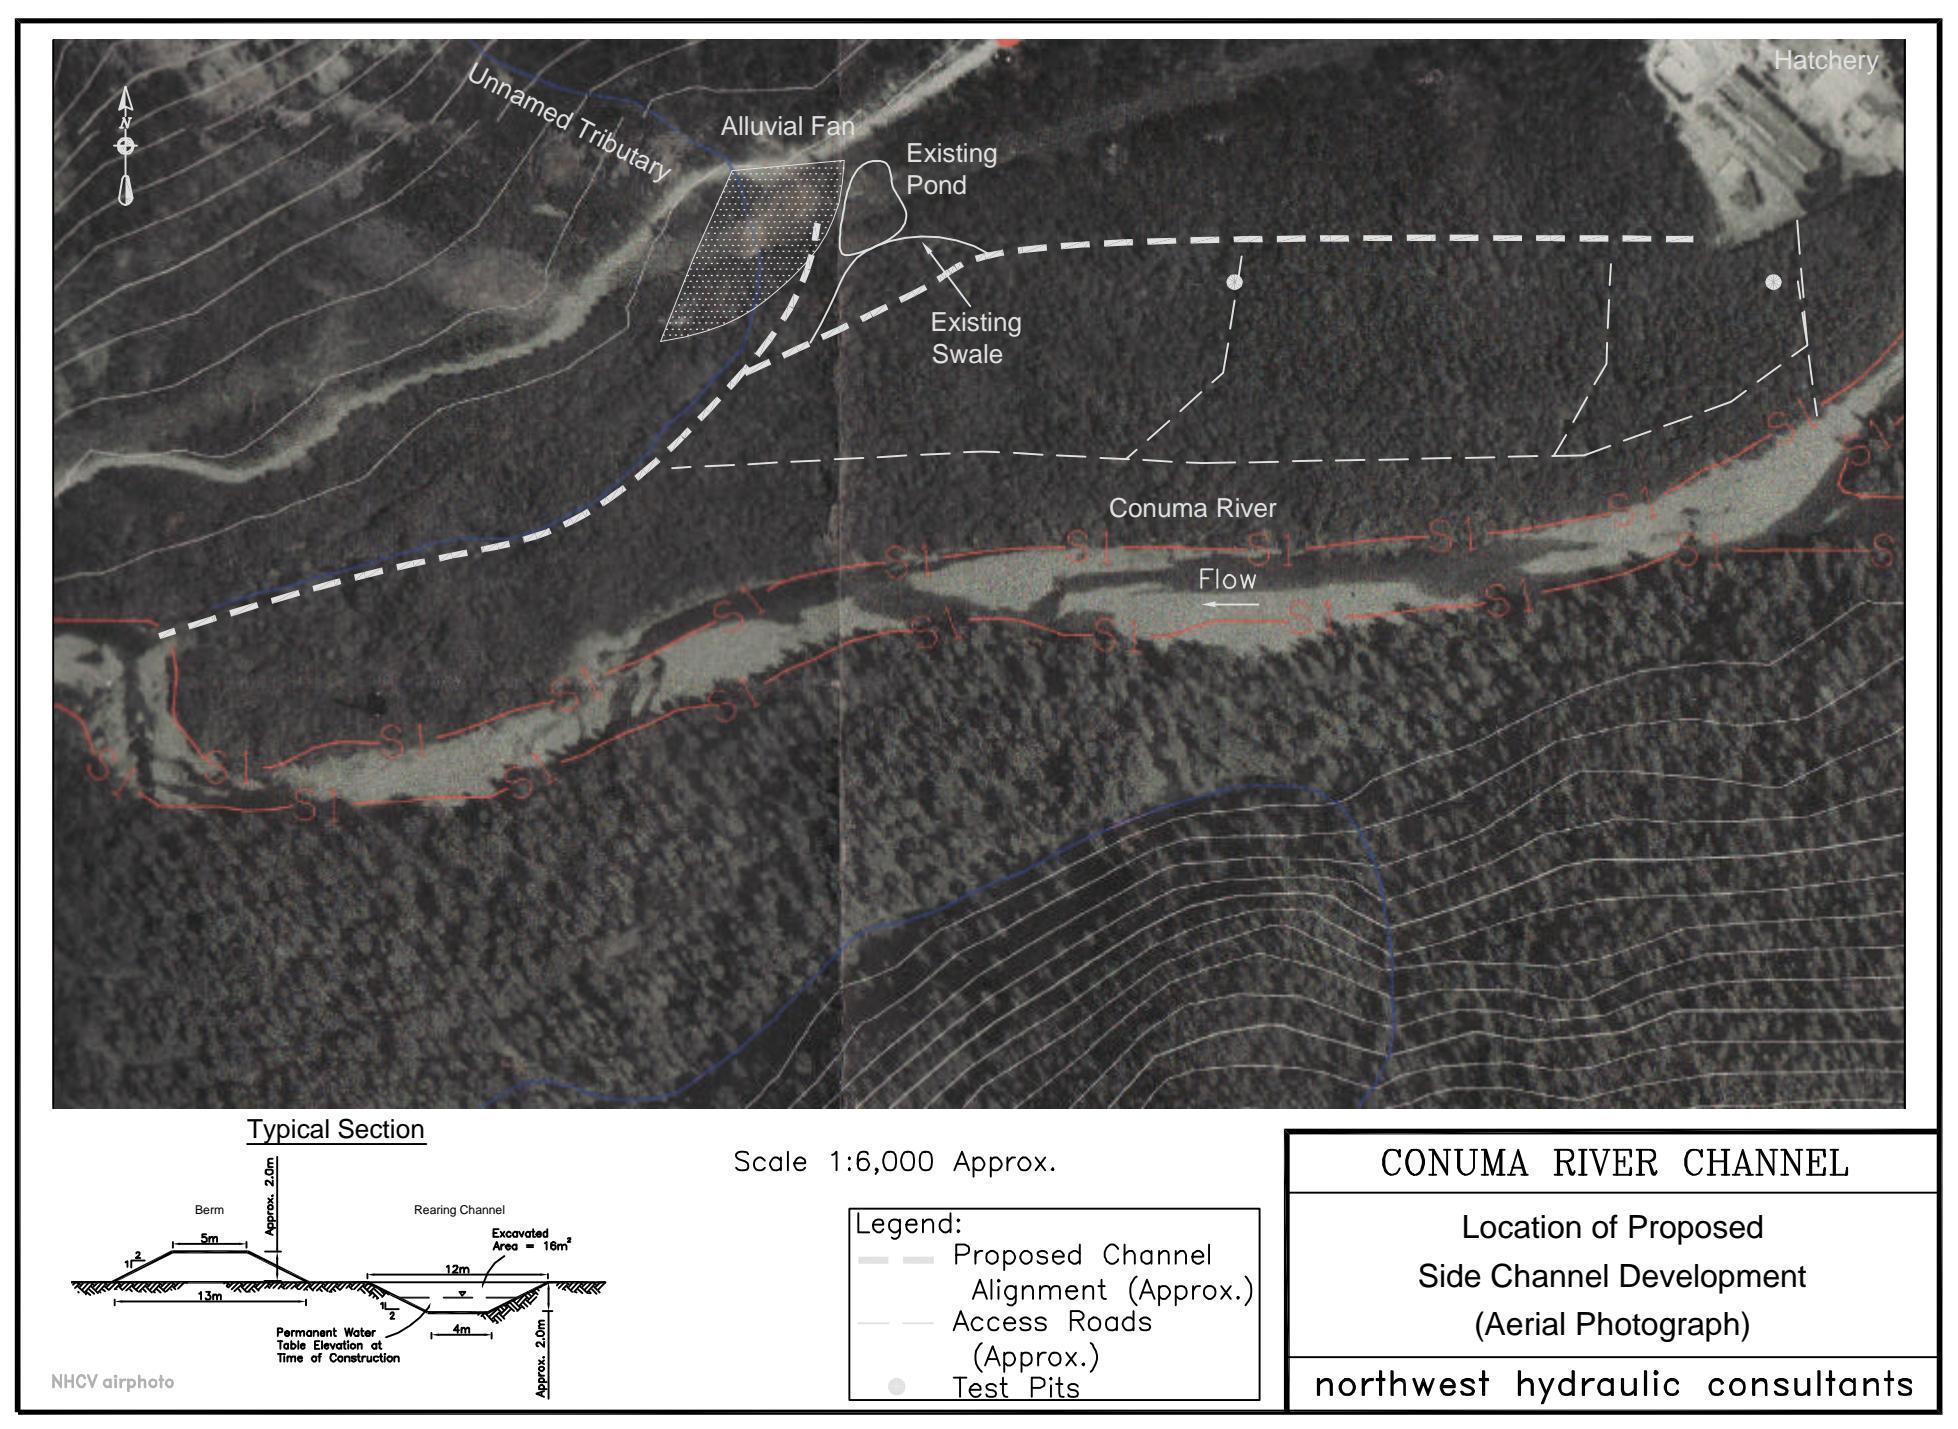
Figure 2

The proposed groundwater channel lies on the right floodplain of Conuma River, downstream of Leagh Creek and the Conuma River fish hatchery. The site lies between the Conuma River delta and Leagh Creek's alluvial fan – a distance of about 1.2km (Figure 2). As Conuma River passes the alluvial fan, it is forced up against the left valley wall, creating a partially protected area of floodplain that varies from 400m wide, at the upstream end, to 150m wide, at the downstream end, as Conuma River switches from the left to the right.

- A channel with a bottom width of 4m (Figure 2),
- 2H:1V side slopes,
- An average depth of excavation of 2m,
- A total channel length of 1000m from 300m below the hatchery to the upstream extent of salt water penetration near the existing access road,
- A total excavated volume of 21,000 m³ allowing for 30% expansion of the volume following excavation,

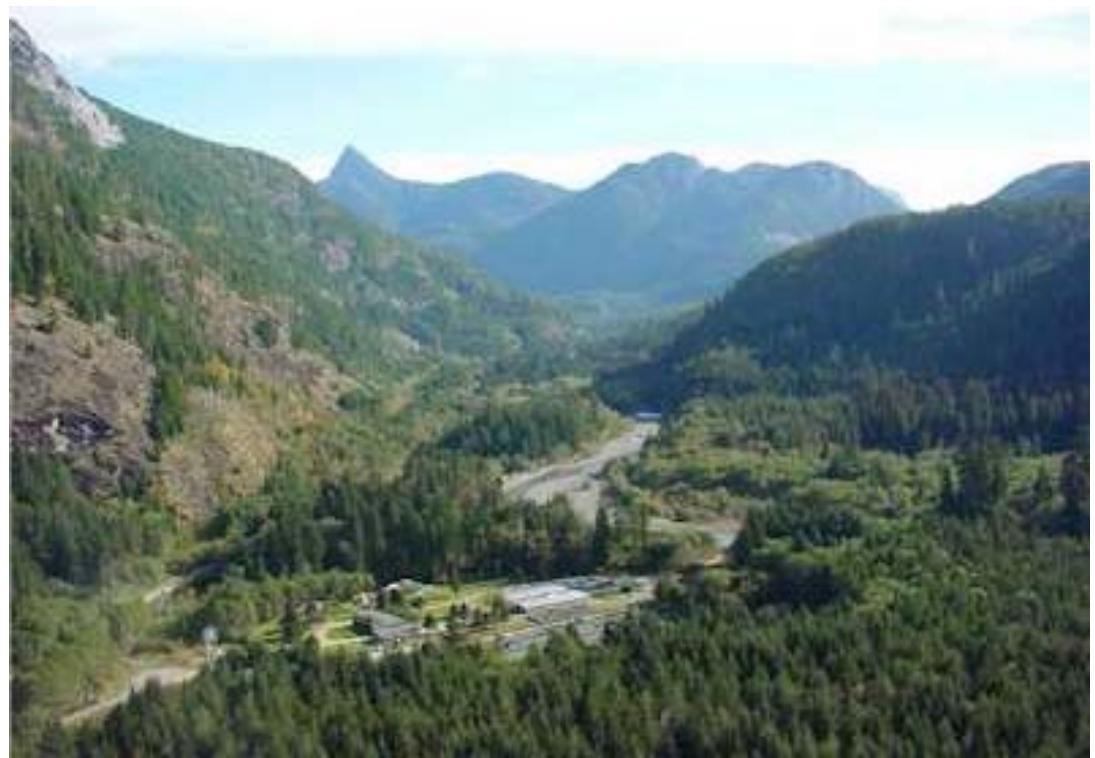
Photo 1: Looking upstream into Conuma River watershed. Conuma River hatchery is visible in lower centre (photo from DFO website).

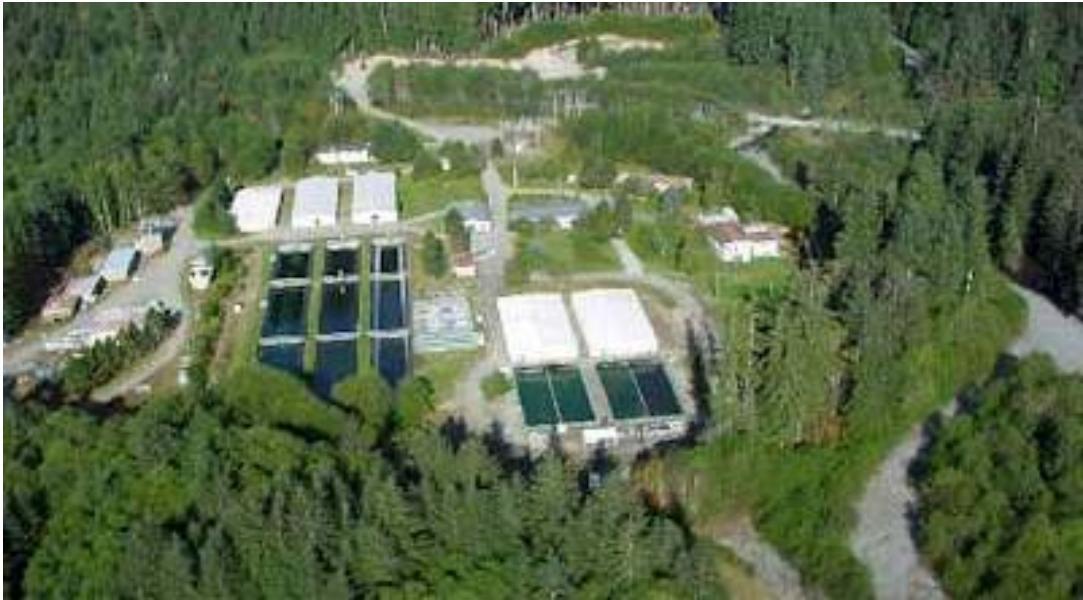
Photo 2: Looking down at the Conuma River hatchery (photo from DFO website).
